5.0 Findings and Recommendations

***Surface Water Monitoring Results for Acequias Located within
Bernalillo County, 2005***

Surface Water Monitoring Results for Acequias Located within Bernalillo County, 2005

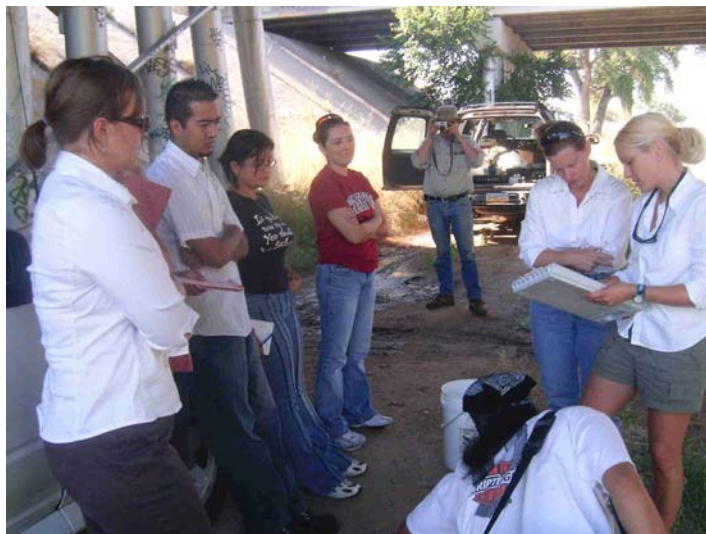
NMED trains community promotoras on surface water sampling techniques. June 2005

NMED personnel sampled three of the eight sites (sites 2, 3, and 4), while the other five sites (sites 1, 5, 6, 7, and 8) were sampled by the South Valley Partners for Environmental Justice partners and promoters. NMED Surface Water Quality Bureau personnel trained personnel and promoters on the following: 1) sample collection, 2) quality assurance, and 3) quality control. The training was conducted based on EPA approved quality assurance/quality control protocols.

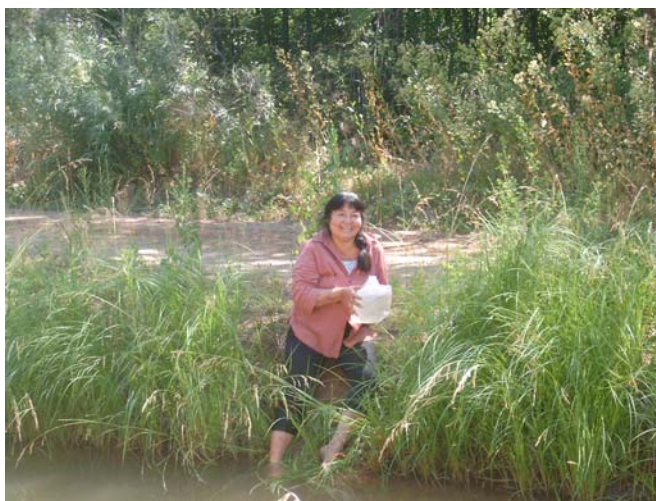
Gloria Castillo collects water from the Isleta Indian Ditch site, June 2005
